X-TYPE

XT501-S948

TECHNICAL BULLETIN

Front Seat Stabilization Kit –
Change Of Specification –
Service Action S948

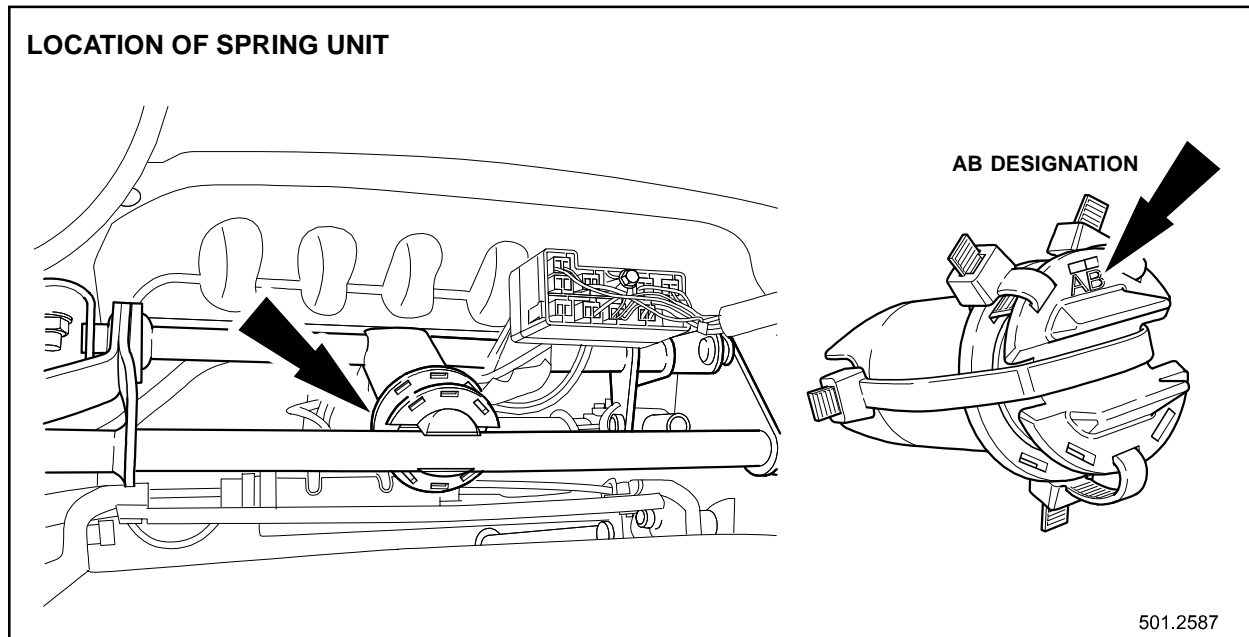
ILLUSTRATION 1

1. Check under seats to confirm the presence of spring unit without 'AB' markings.
See Illustration 1.
